Diaphragm Seal Refurbishment Program

Giving pressure instruments a second life

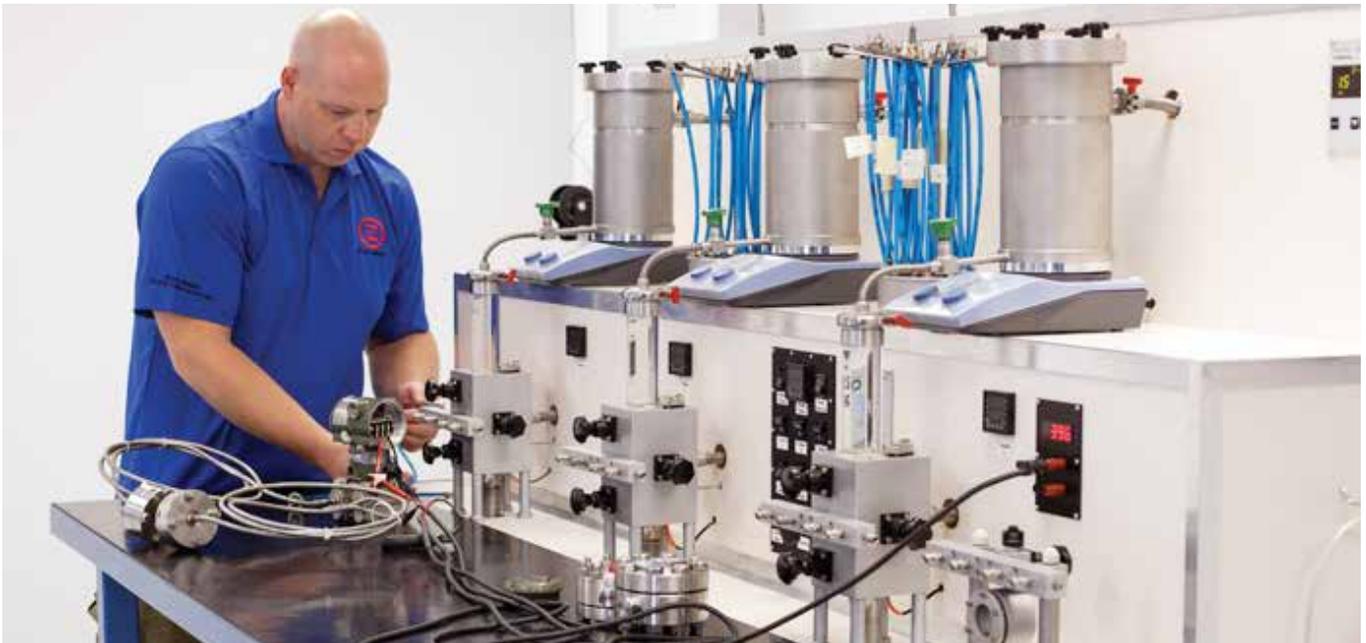
The Influence of Temperature

A pressure instrument with Diaphragm Seals is filled under high vacuum at a temperature of +/- 20 °C. When the instrument with Diaphragm Seals is being used at an operating temperature different to this, a measurement error will occur. When the process and/or ambient temperature increase, the filling fluid will expand resulting in a pressure build up, that will be measured by the pressure retainer on top of the actual process pressure. On request, Bliss Americas can determine the expected additional measurement error of an application, so it can be compensated in the system. It is also possible to get a reliable measurement, where the pressure instrument will be set at a given operating process temperature.
